**WATER MANAGEMENT DEPARTMENT**

RE: Overflow Report – 1003 Market Street  
NPDES Permit# TN0028827

## Service Request

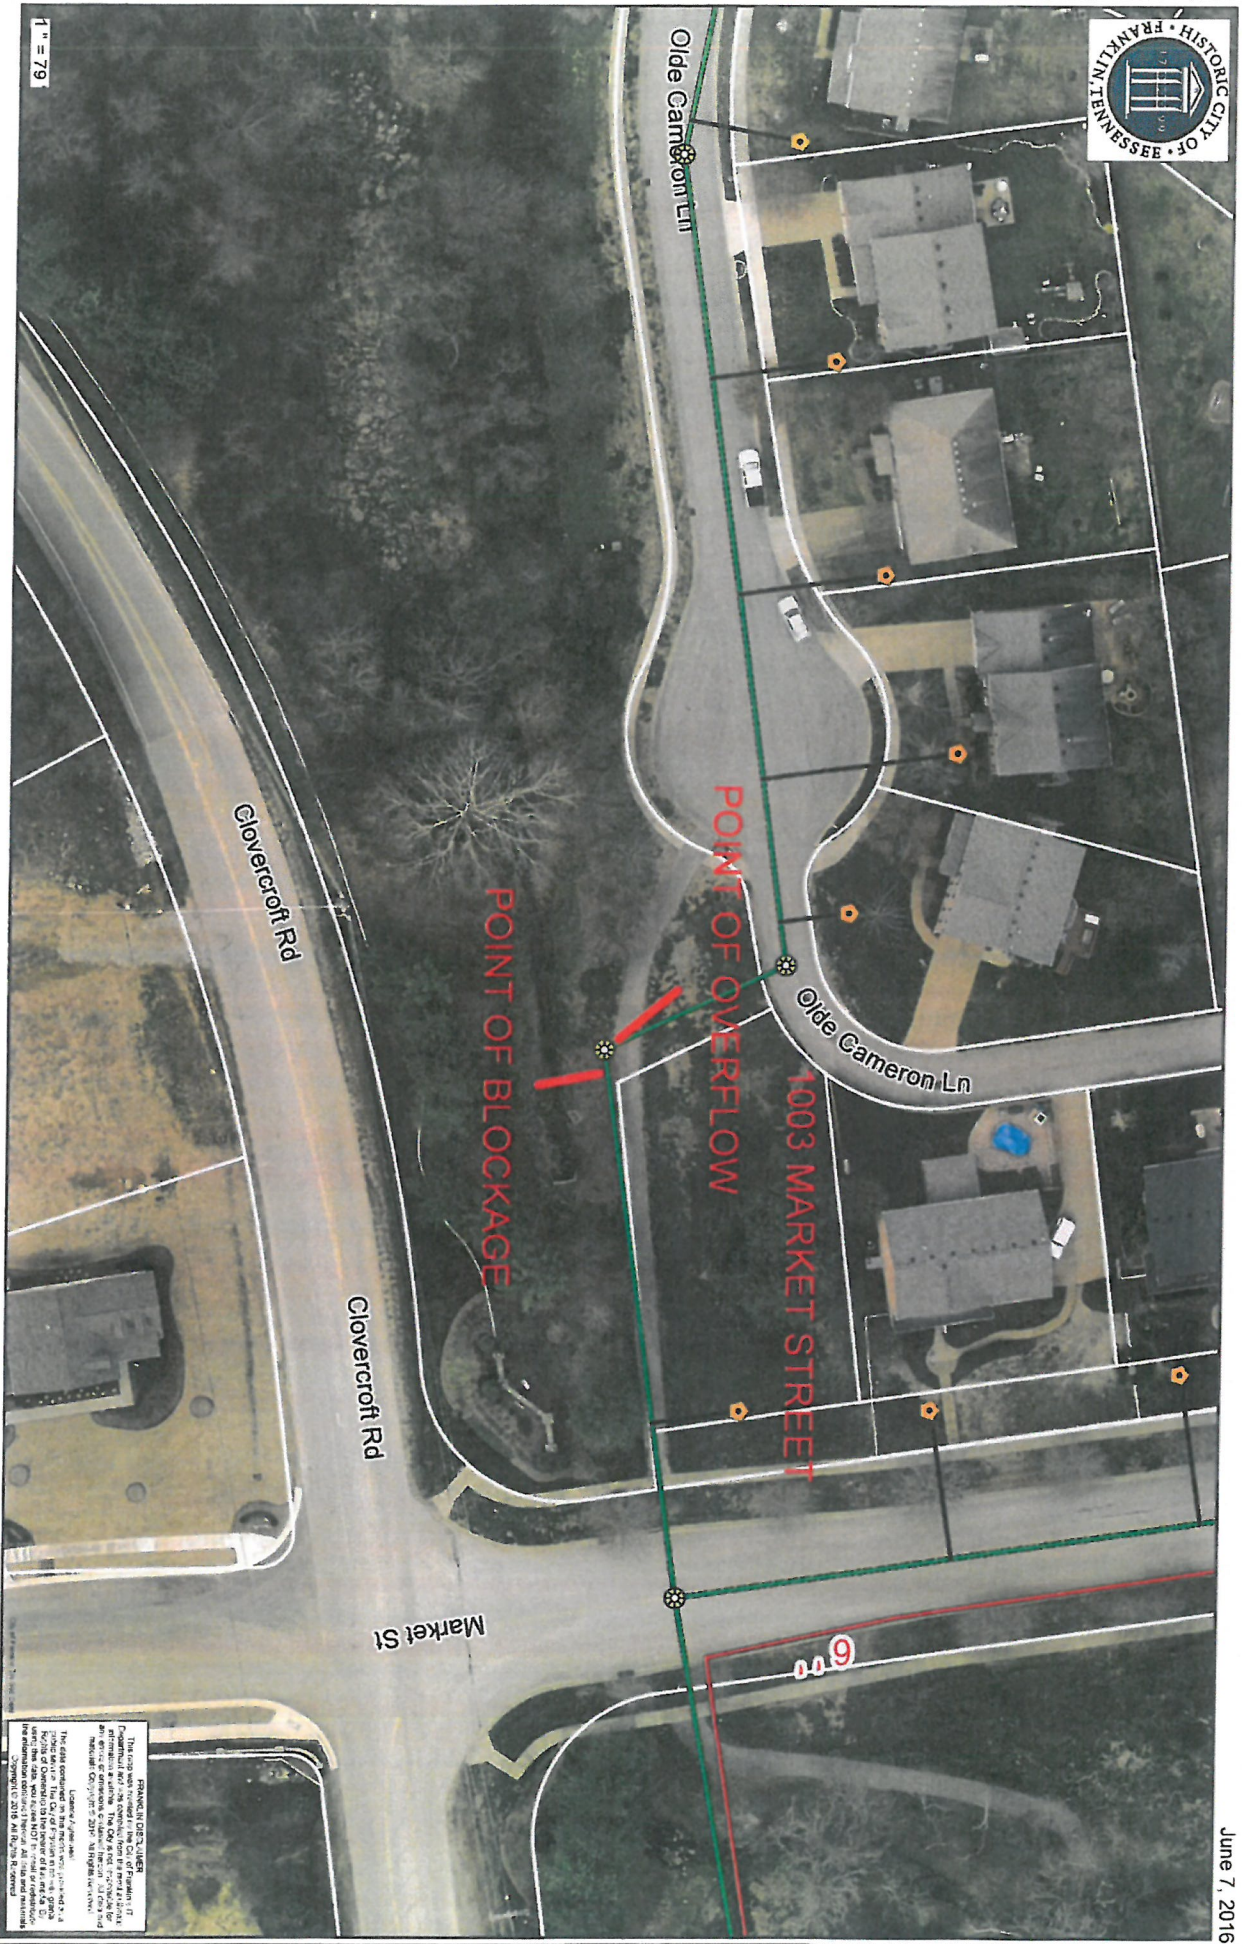
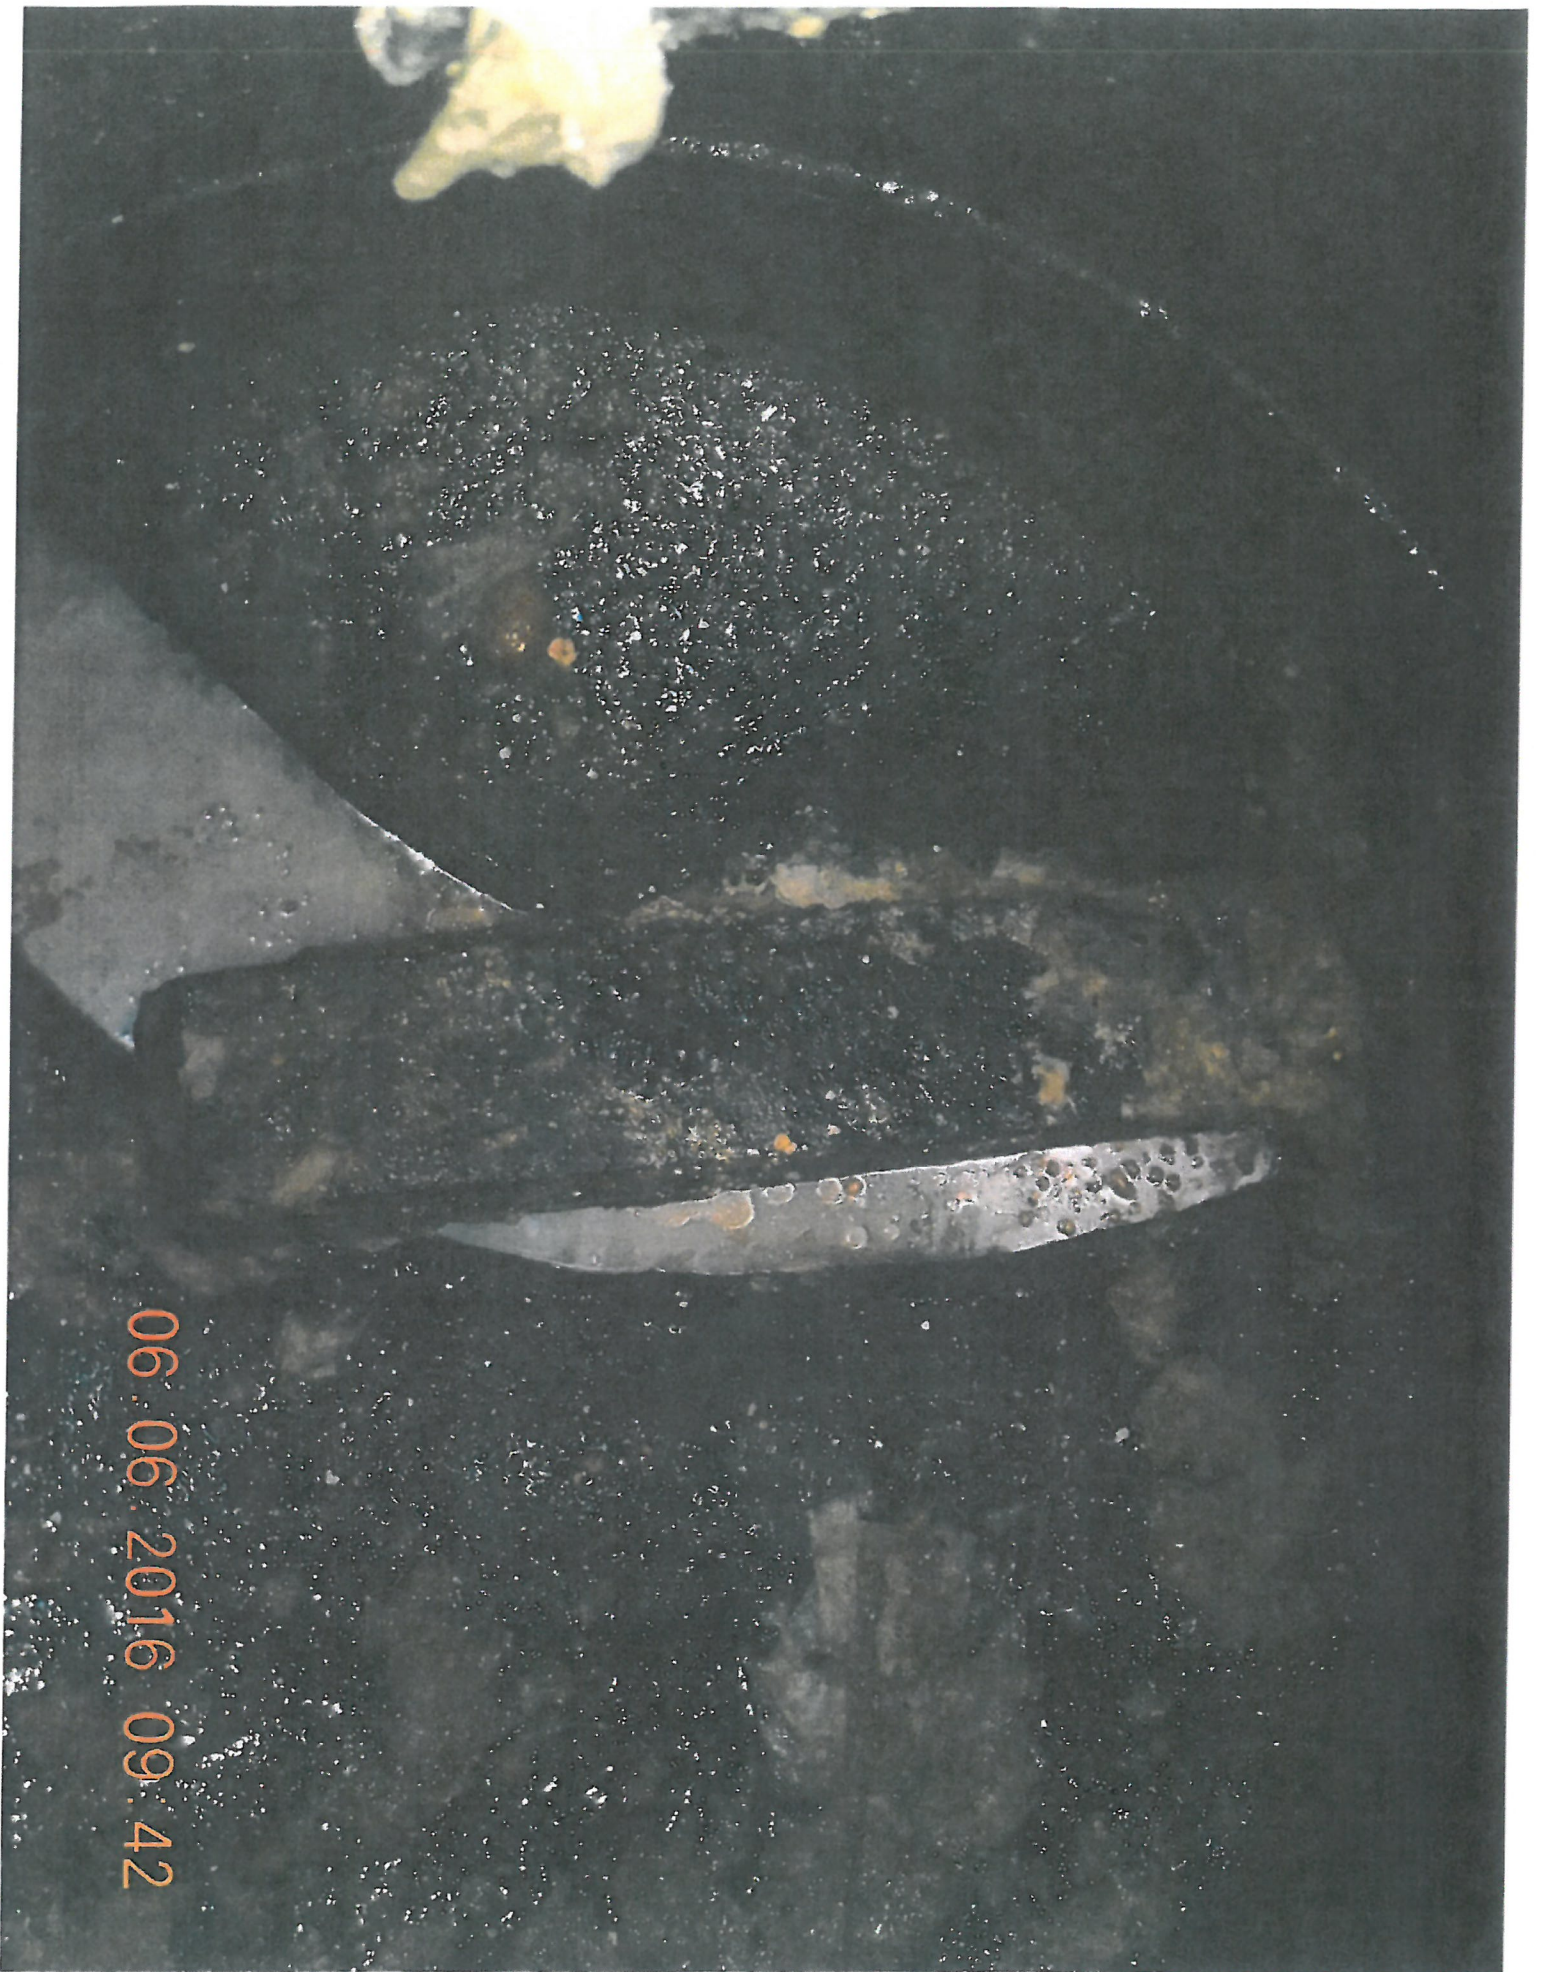
I have attached a map of the area.
